DAM INSPECTION CHECKLIST POSSUM POINT POWER STATION POND ABC

INSPECTION DATE: JAN. 27, 2016

INSPECTED BY: K. ACREE

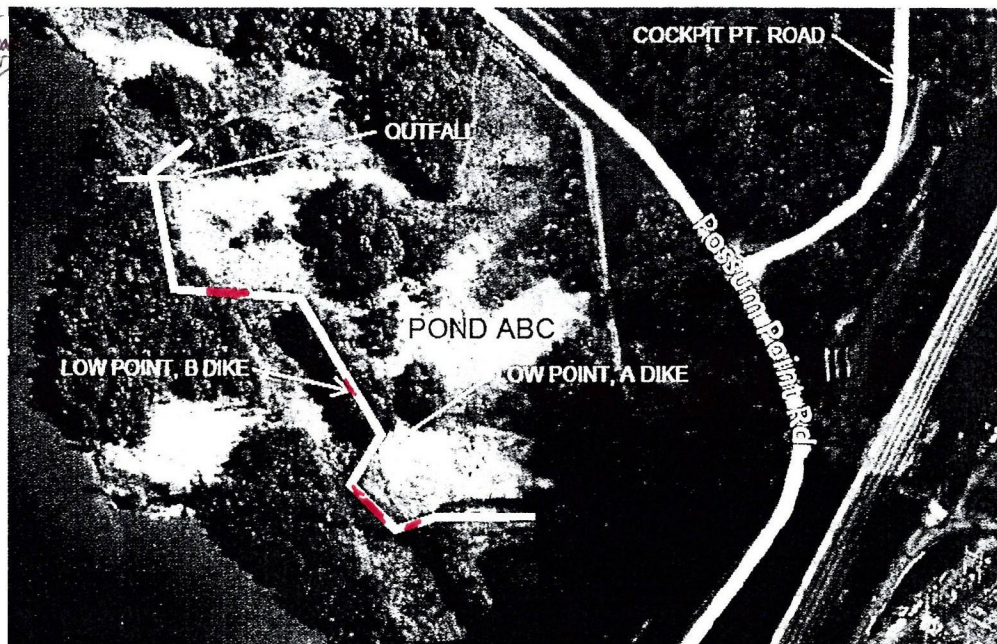
* See figure below.

Location/ Condition	(y/n)	Change (y/n)	Comments
Low Point, A dike*			
Flow	N	N	2:14 PM → SNOW COVERED ASSUMED NO CHANGE;
Erosion	N	N	NO STANDING WATER AGAINST SAND BAGS; SAND BAGS APPEARED TO BE IN-PLACE; RIPRAP APPEARED TO BE IN-PLACE
Low Point, B dike*			
Flow	N	N	2:11 PM → SNOW COVERED ASSUMED NO CHANGE; STANDING
Erosion	N	N	WATER AGAINST SAND BAGS SAND BAGS APPEARED TO BE IN-PLACE. STANDING WATER BETWEEN SAND BAGS & OUTSIDE PART OF EMBANKMENT (SMALL AMOUNT), BUT NO STANDING WATER BETWEEN OUTSIDE ^{INSIDE} PORTION OF EMBANKMENT AND SAND BAGS
Outfall water surface El. (top of stoplogs to water)			2:00 PM → SNOW APPROX. 3 FT. FROM WEIR; RIGHT SIDE OF WEIR WAS MOIST, NO FLOW AND NO STANDING WATER AGAINST WEIR

- STANDING WATER AT TOE OF INSIDE EMBANKMENT OF POND C (TYPICAL OF POND A & B)

- STANDING WATER AT TOE OF EMBANKMENT AS NOTED BELOW.
